# VINTAGE TEST EQUIPMENT

## The Tektronix Type 545A Scope Save Our Scopes!

BY LOREN P. ASHWORTH

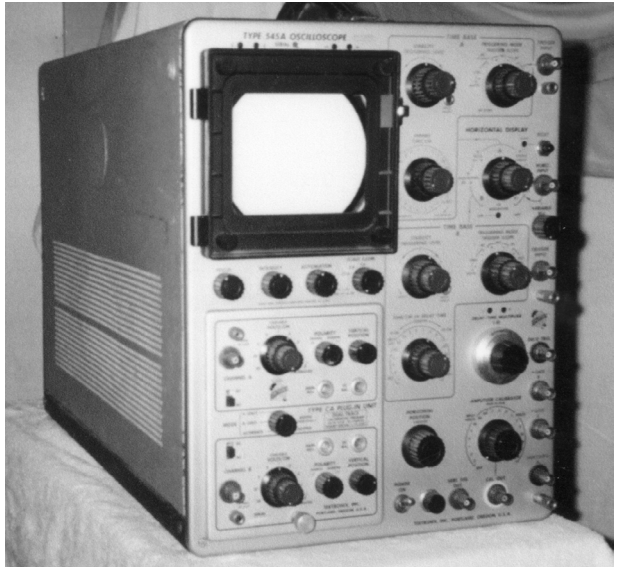
Figure 1. The Tektronix Type 545A scope as found with plug-ins and a camera bezel.

The classic Tektronix Type 545A with camera bezel, ca 1958-1960, shown in Figure 1, was recently rescued. Figure 2 shows the scope with the Type CA dual-trace, plug-in slid out to show its tubes. The unit provides both standard and time delay sweep. A very early example of a time delay scope, it was complete when given to me, save four or five 6DJ8 tubes that had been removed by some previous owner.

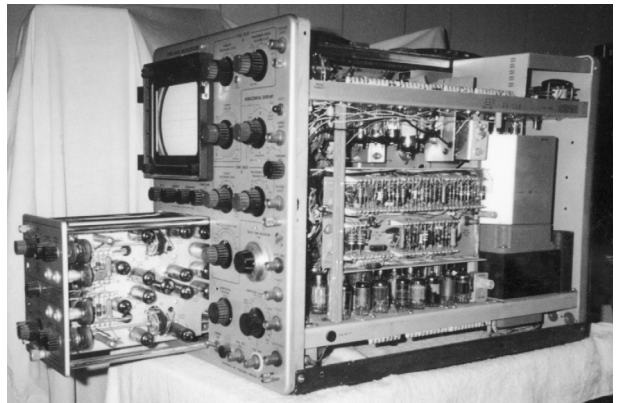
Figure 2. A right view of the Type 545A showing the Type CA dual trace plug-in to show its tubes. A dual-trace module allows two different signals to be displayed simultaneously, one above the other on the CRT face.

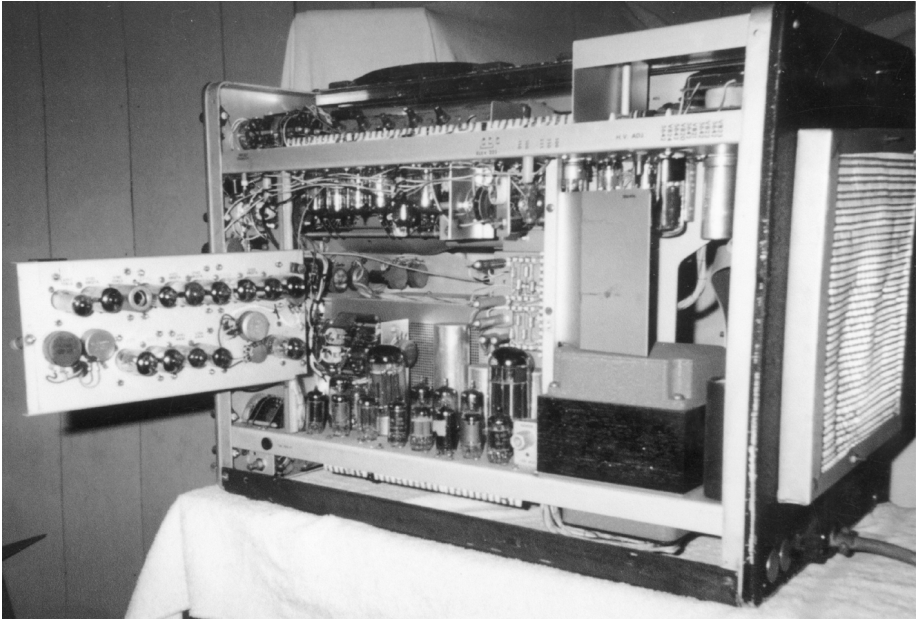
Figure 3. A second right view showing the sub-chassis open. It's all tubes, except for the many silicon diodes in the B+ power supply visible above and left of the massive power supply transformer.

The slightly modified instrument sports an incredible tube count of 88 tubes. Around 500 watts of power are required to operate the scope. Figure 3 provides another right-hand view of the scope with the subchassis in open position. Figure 4 shows even more of the tubes and a view inside the plug-in module.

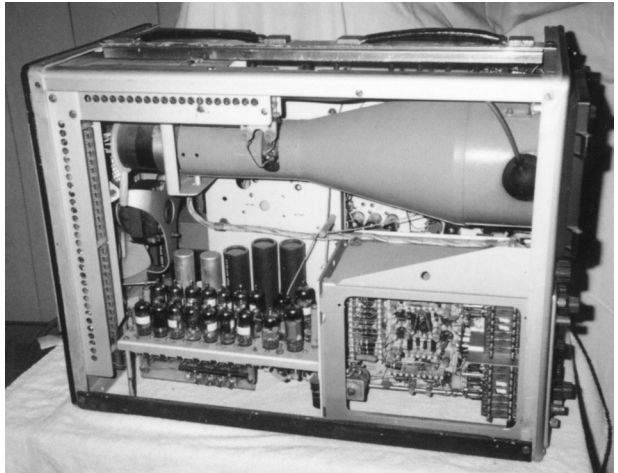
Figure 4. An open left side view showing more tubes. The plug-in is inserted showing the inside wiring.
