RESTORATION TOPICS

Rebuilding A Scott Allwave 23

BY FRANK DROST

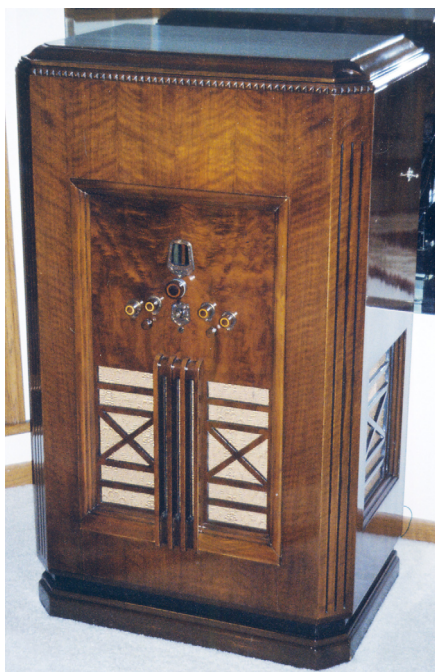
Figure 1. Frank Drost's first rebuild, shown completed here, was this Scott Waverly Grande with an Allwave 23 chassis.

Then one Saturday morning, I stopped into Great Northern Antique Radios in Minneapolis, and found a very nice Scott Waverly Grande that had the Allwave 23 chassis in it. The chrome was as nice as one could ever hope to find. I was so impressed with the quality of the cabinet and chassis condition that I just knew that this was too good a set to pass by. A deal was struck, and it was to become the first of several Scotts in my collection. See Figure 1.

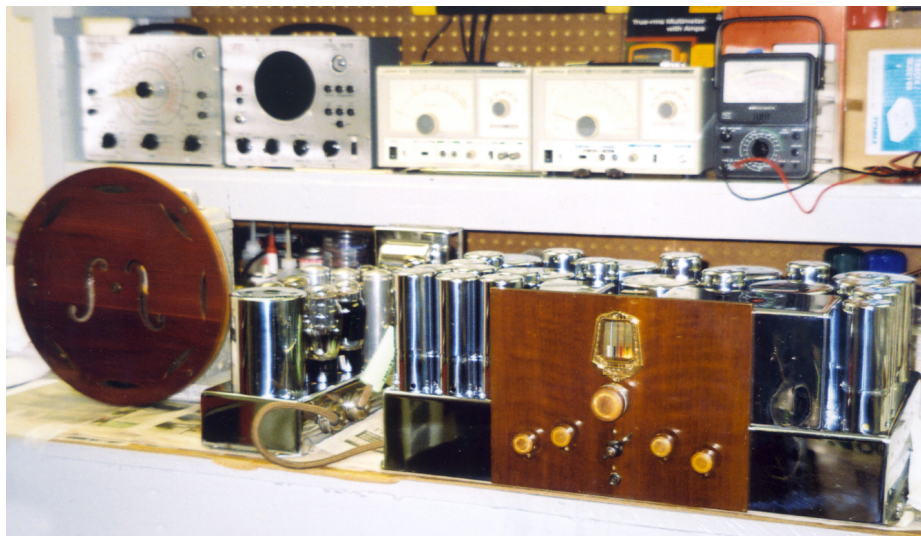
Figure 6. The completely restored Allwave 23 on the workbench for testing. Left to right, the speaker with an optional diffuser, the power amplifier/power supply, and the main chassis.

Once both chassis have been restored, it is time to connect them up with each other and the speaker. Figure 6 shows the completed set on the work bench for testing. Refer to the service instructions once again and look for the info on speaker connections.
