RESTORATION TOPICS

Fisher Custom Electra II Restoration

This article will discuss the restoration of a 1958 Fisher Custom Electra II Console Radio Phonograph (figure 1).

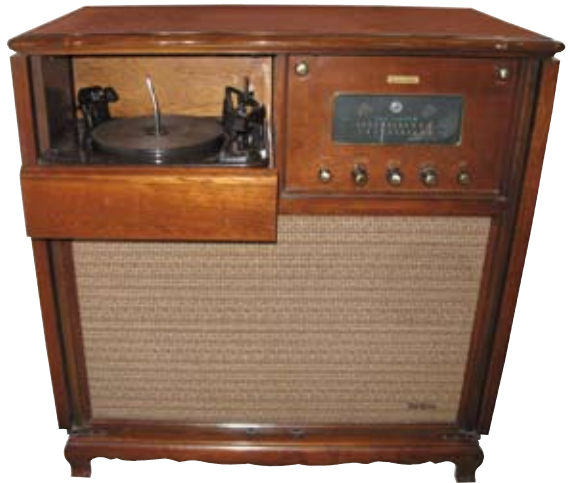
Figure 1. Full front photograph (February 2011 cover photo)

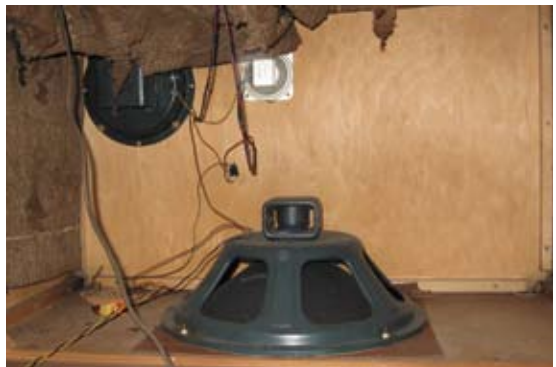
The chassis had plenty of dust and dirt. My first surprise was that the console had three speakers: a 15" woofer facing down, an 8" midrange and tweeter facing front. The insulation needed to be reattached (figure 2).

Figure 2. Speaker compartment

The chassis was returned to the cabinet. At the same time I replaced the capacitors in the speaker network.

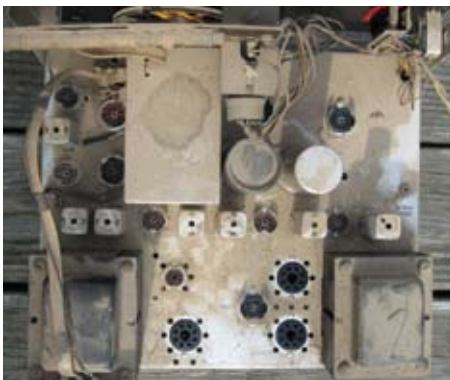
Figure 4. Top chassis – before

faceplate. The controls are AC Power on/off; station selector; tone – bass & treble; volume/loudness (three position loudness control); and the selector control with AM, FM, AES, RIAA, LP, NAB, Tape, Aux 1, and Aux 2. (Figures 4 & 5). The secondary controls are Presence and Brilliance. The secondary controls are two wire wound pots connected to the console faceplate (figure 6 & 7). The output tubes are EL37s. Very expensive if you drop one!

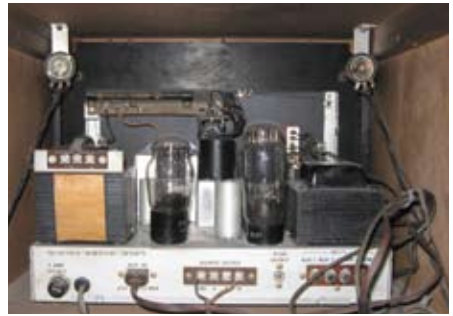
Figure 7. Chassis - rear view in cabinet

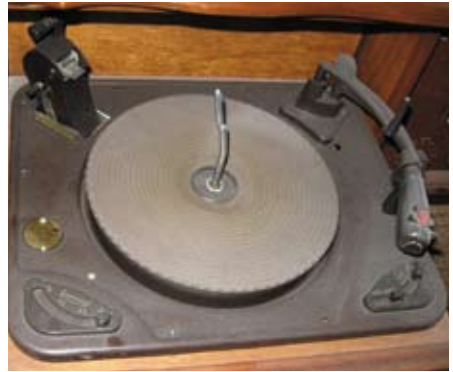
The turntable is a Garrard RC-88/4 record changer (figure 8).

Figure 8. Phonograph

Now what to do with the Garrard RC-88/4 record changer. Since I'm not very good at repairing turntables I did the best thing possible - I gave it to my friend Chris who knows what he's doing. It works fine now after he cleaned out the 50-years of hardened grease and lubricated it. It probably can use a new idler wheel but I'm satisfied with its performance. In the near future there will be an article on repairing this turntable.

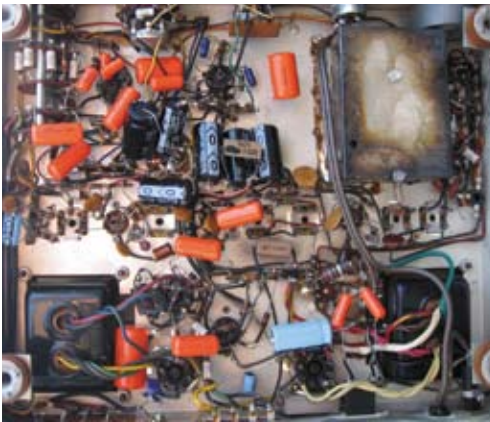
Figure 11. Chassis bottom – after

I ended up replacing 26 capacitors, some lamps, a few resistors, and a couple of tubes. This chassis uses six mini indicator lamps for AM, FM, Phone, Tape, Aux 1, and Aux 2. It also uses two #47 lamps to illuminate the dial. All controls and tube sockets were cleaned. The chassis was

partially cleaned with care to avoid removing labels (figures 9, 10 & 11).

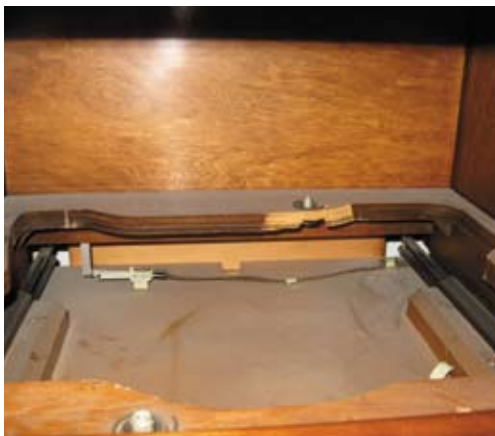
In the turntable compartment there was a lamp

Figure 12. Phonograph compartment 1

that wasn't working. There was no voltage at the lamp socket. The wires from the socket to the chassis were hidden by a piece of wood. At the chassis was 6.3 vac going to the lamp. I figured that maybe the wires were broken at some point under the wood. When I removed the turntable for servicing I was surprised to find the lamp is activated by a switch. Moving the turntable drawer in and out opens and closes the switch. Cleaning the switch contacts fixed the problem (figure 12).
