RESTORATION TOPICS

Fisher Custom Electra II Restoration

This article will discuss the restoration of a 1958 Fisher Custom Electra II Console Radio Phonograph (figure 1).

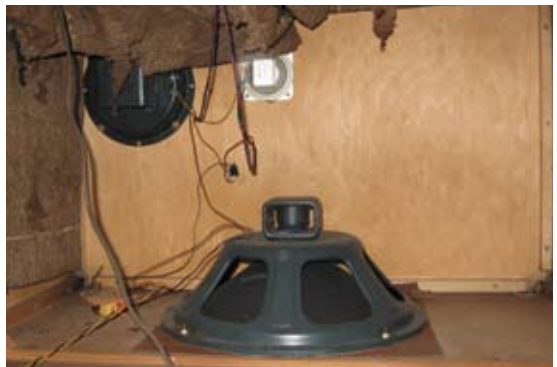
The chassis had plenty of dust and dirt. My first surprise was that the console had three speakers: a 15" woofer facing down, an 8" midrange and tweeter facing front. The insulation needed to be reattached (figure 2).

Figure 2. Speaker compartment

The chassis was returned to the cabinet. At the same time I replaced the capacitors in the speaker network.

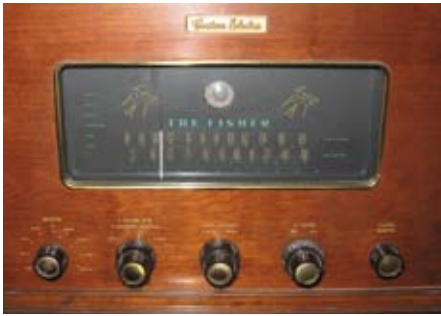
faceplate. The controls are AC Power on/off; station selector; tone – bass & treble; volume/loudness (three position loudness control); and the selector control with AM, FM, AES, RIAA, LP, NAB, Tape, Aux 1, and Aux 2. (Figures 4 & 5). The secondary controls are Presence and Brilliance. The secondary controls are two wire wound pots connected to the console faceplate (figure 6 & 7). The output tubes are EL37s. Very expensive if you drop one!

Figure 6. Chassis front panel

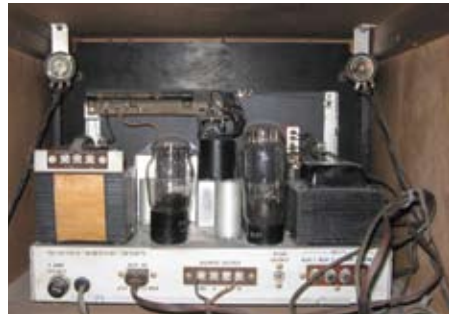
Figure 7. Chassis – rear view in cabinet

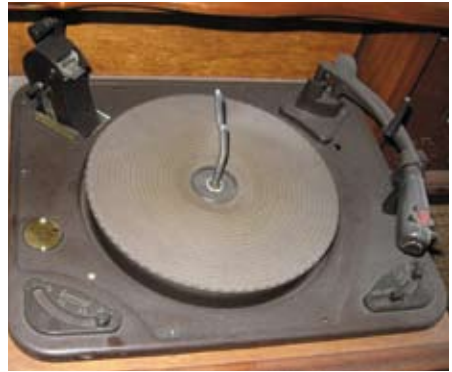
The turntable is a Garrard RC-88/4 record changer (figure 8).

Figure 8. Phonograph

Now what to do with the Garrard RC-88/4 record changer. Since I'm not very good at repairing turntables I did the best thing possible – I gave it to my friend Chris who knows what he's doing. It works fine now after he cleaned out the 50-years of hardened grease and lubricated it. It probably can use a new idler wheel but I'm satisfied with its performance. In the near future there will be an article on repairing this turntable.

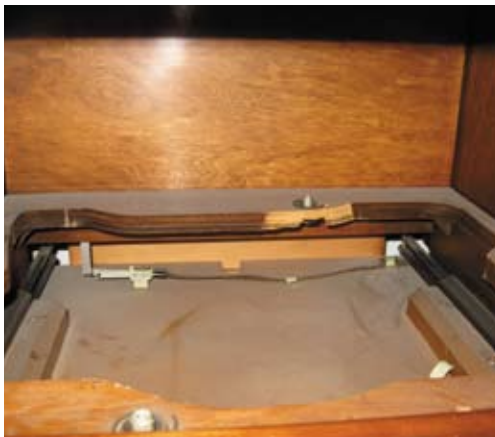
In the turntable compartment there was a lamp

Figure 12. Phonograph compartment 1

that wasn't working. There was no voltage at the lamp socket. The wires from the socket to the chassis were hidden by a piece of wood. At the chassis was 6.3 vac going to the lamp. I figured that maybe the wires were broken at some point under the wood. When I removed the turntable for servicing I was surprised to find the lamp is activated by a switch. Moving the turntable drawer in and out opens and closes the switch. Cleaning the switch contacts fixed the problem (figure 12).
