Heathkit Audio Generator Model AG-9A

BY JOHN VUOLO

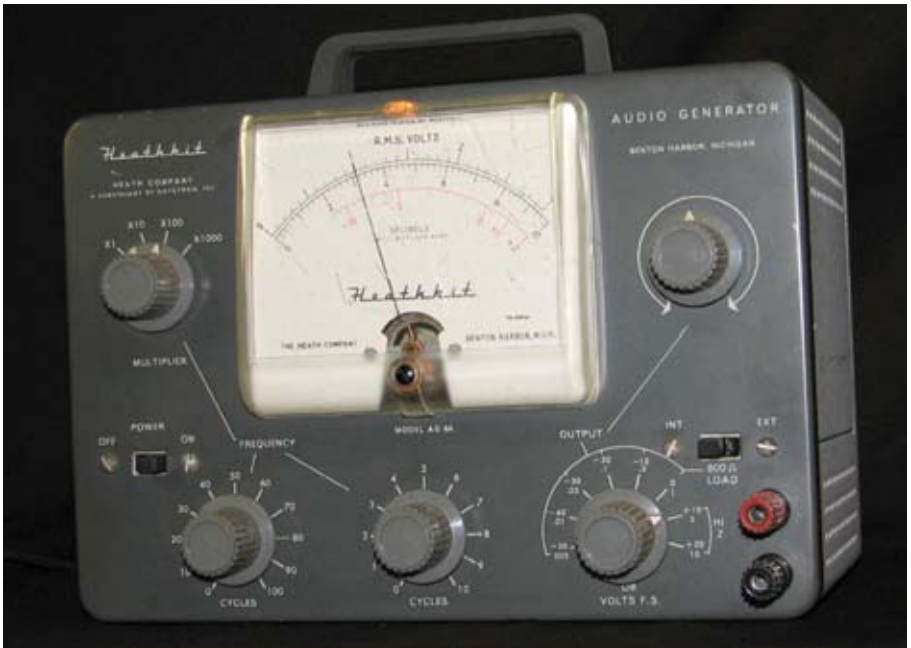
The Heathkit AG-9A Audio Generator is a simple, yet versatile instrument. It provides ease of operation in a multitude of test setups encountered in audio work. The wide range of repeatable frequencies and the metered low distortion output voltages, covering nearly all values encountered in audio work, contained in the conveniently small cabinet meant this instrument would have a preferred spot on my workbench—once I got it going.

The first repair I made to the AG-9A was in the power supply. It uses the conventional power transformer full-wave rectifier circuit feeding a ripple filter consisting of two capacitors and a choke. I found that I had to replace the 6X4 tube

as well as the dual 40- μ f capacitors in the power supply. That brought the voltages back up. I also had to replace the pilot lamp.

I found that both crystal diodes had to be replaced. I also tested all the resistor and capacitor values and replaced any out-of-tolerance ones I found. Fortunately at the time I was able to get the needed parts from Heathkit. I don't remember now what I paid for them, but it had to be \$10 or less.

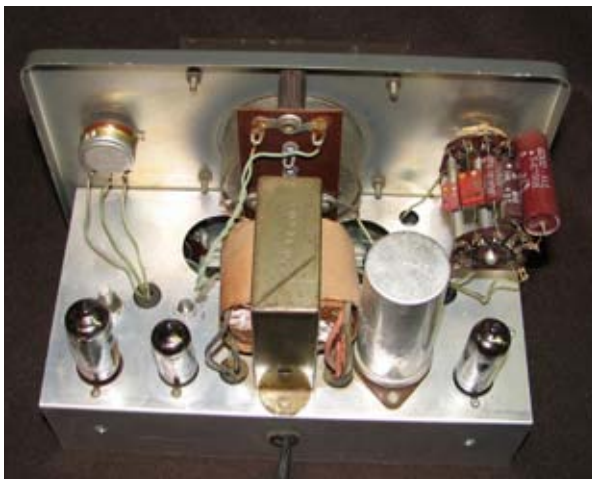
*Top: Top view of the AG-9A
Middle: Bottom view of the AG-9A
Bottom: Oscilloscope pattern*

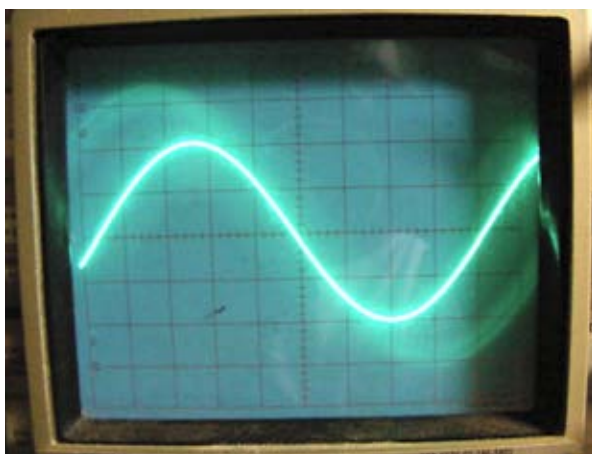
I brought the AG-9A over to my friend's place and we used his Oscilloscope to check it out. I used the AG-9A for years but retired it some two decades ago for better equipment. I recently brought it back out of mothballs, however, and found that it's still about as accurate today as I remember it was back then. Over the years I've repaired one or two other AG-9As for friends who, for various reasons, didn't want to take on the repair themselves. Some of the parts are harder to come by, but with a little searching and ingenuity you, too, can still repair one.
